RESEARCH MEMORANDUM

AN ANALYSIS OF THE EFFECT OF STRUCTURAL FEEDBACK
ON THE FLUTTER OF A CONTROL SURFACE HAVING A
POWER-BOOST SYSTEM

By Robert H. Barnes

June 10, 1952

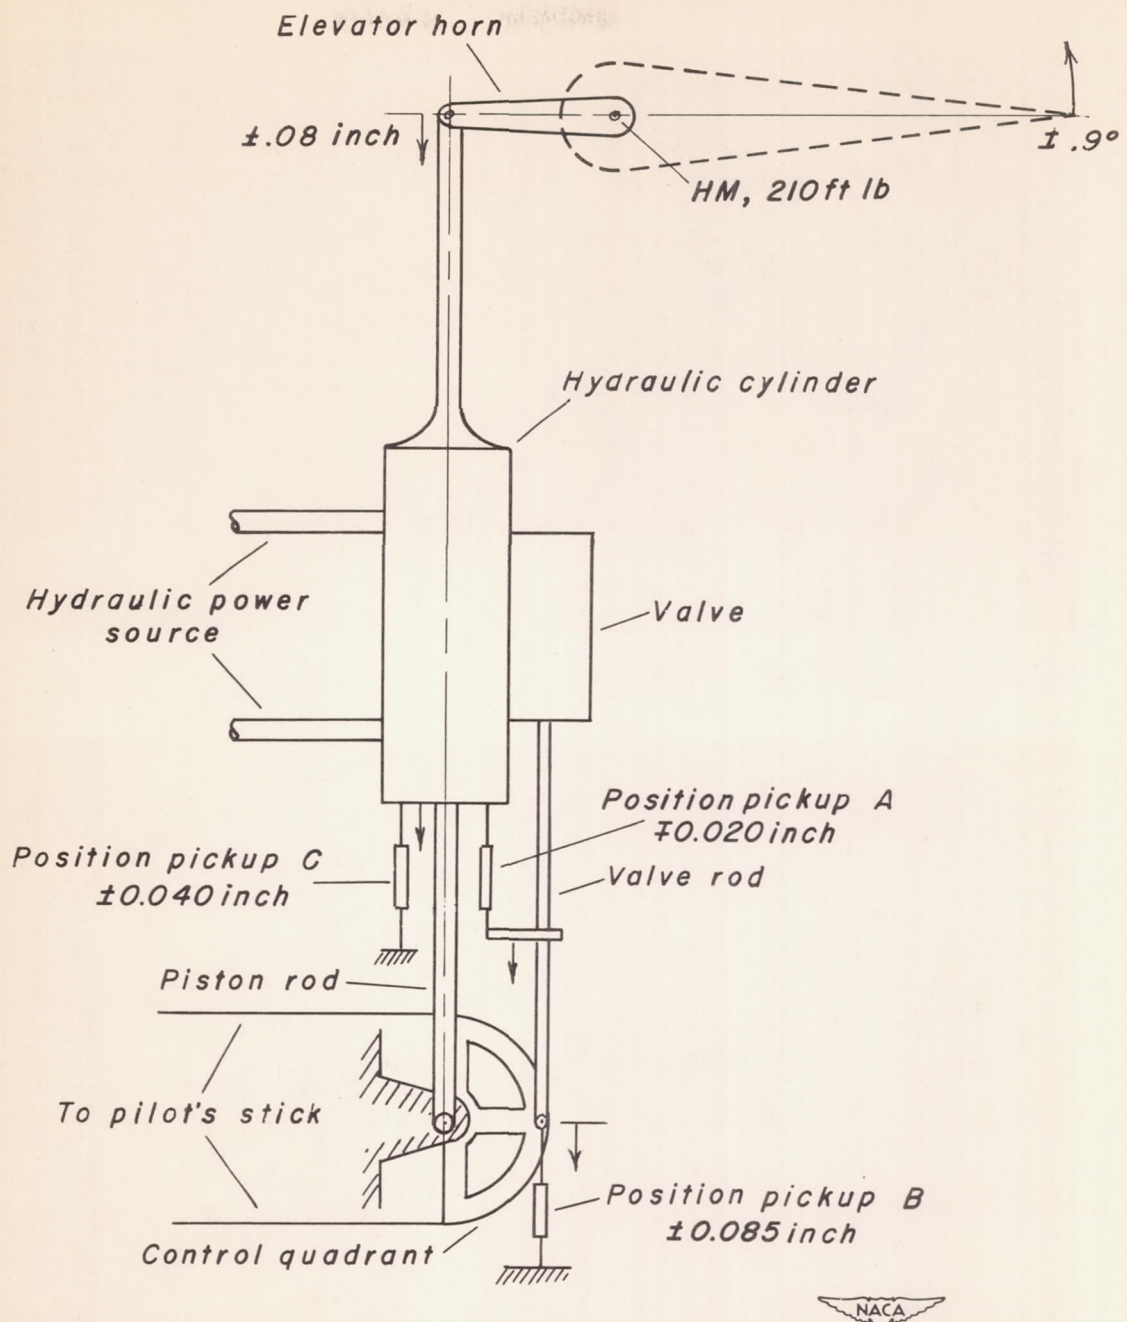
Figure 3.- Schematic diagram of elevator control system, test instrumentation, and amplitudes of motion measured during flutter.

Analysis of the oscillograph records taken during flutter furnishes some information on the behavior of the elevator and the power-boost system. In figure 3 are noted the amplitudes of motion indicated by the position pickups. Also noted is the angular displacement amplitude of the inner end of the elevator and the amplitude of the hinge moment. The directions of motion indicated in the figure are those considered positive in relation to the signs of the amplitudes. The double-sign notation is employed since all the motions were either nearly in phase or nearly out of phase. Note that the valve rod - hydraulic cylinder relative travel was 180° out of phase from the other motions. No signs are noted on the hinge-moment amplitude since the phase of this quantity relative to the motions was not known due to failure of the time synchronization device. In order to obtain a complete picture of the motions which took place, it is necessary to know the motion of the elevator horn which, in turn, requires that it be known whether the boost system was driving the elevator or vice versa. Consideration of the hinge-moment amplitude and the characteristics of the boost system indicates the answer to this question. In order for the elevator to be driving the boost system with a hinge moment of 210 foot-pounds, the frequency of oscillation would have to be near the resonant frequency of the boost system. However, information from the manufacturer based on experimental tests indicates that the resonant frequency was considerably greater than the frequency of flutter (36 cps). Since the potential output of the

boost system was about 1750 foot-pounds for the measured valve motion, it is evident that the boost system was driving the elevator during the observed flutter. Then, using the measured hinge moment to determine the twist of the torque tube, the motion of the elevator horn was calculated.

In order for the boost system to drive the elevator, it is necessary for something to cause the valve rod to move. If the structural system between the elevator hinge line and the control quadrant was perfectly rigid, such a motion could not occur since no disturbance was introduced into the control quadrant. Comparison of the various motions measured will show that inconsistencies are present which can be explained only by admitting the existence of structural deformation.

If it is assumed that the control quadrant was fixed and there was no structural deformation, then the motion of the control valve relative to the hydraulic cylinder (position pickup A) would be equal to the motion of the elevator horn. The motion of pickup A has been shown to have been ± 0.02 inch. Correction of the measured elevator motion for twist of the torque tube, assuming the boost to be driving the elevator, indicates a motion of ± 0.08 inch as in figure 3. Thus, the sum of these motions was not zero. Rather, the sum was ± 0.06 inch. The motions measured by pickups B and C are seen to have been ± 0.09 inch and ± 0.04 inch, respectively, which are of the same order of magnitude as the discrepancy noted above. Consequently, it is apparent that a structural deformation was occurring. The nature of this deformation is not susceptible to analysis, but it is assumed to have been the result of stabilizer torsion. The basis for this assumption is that since the structure (vertical stabilizer) which connected the elevator hinge line and the control quadrant also supported the horizontal stabilizer, the loads causing deformation of this structure must have come initially from the horizontal stabilizer. Since the deformation under consideration is one which caused a variation of the distance between the elevator hinge line and the control-quadrant axis, the imposed load would appear to have been a torsion load on the horizontal stabilizer. For any given loading condition, the torsional deformation of the horizontal stabilizer would have been proportional to this load. Thus a proportionality was assumed between the twist of the stabilizer and deformation of the vertical stabilizer.

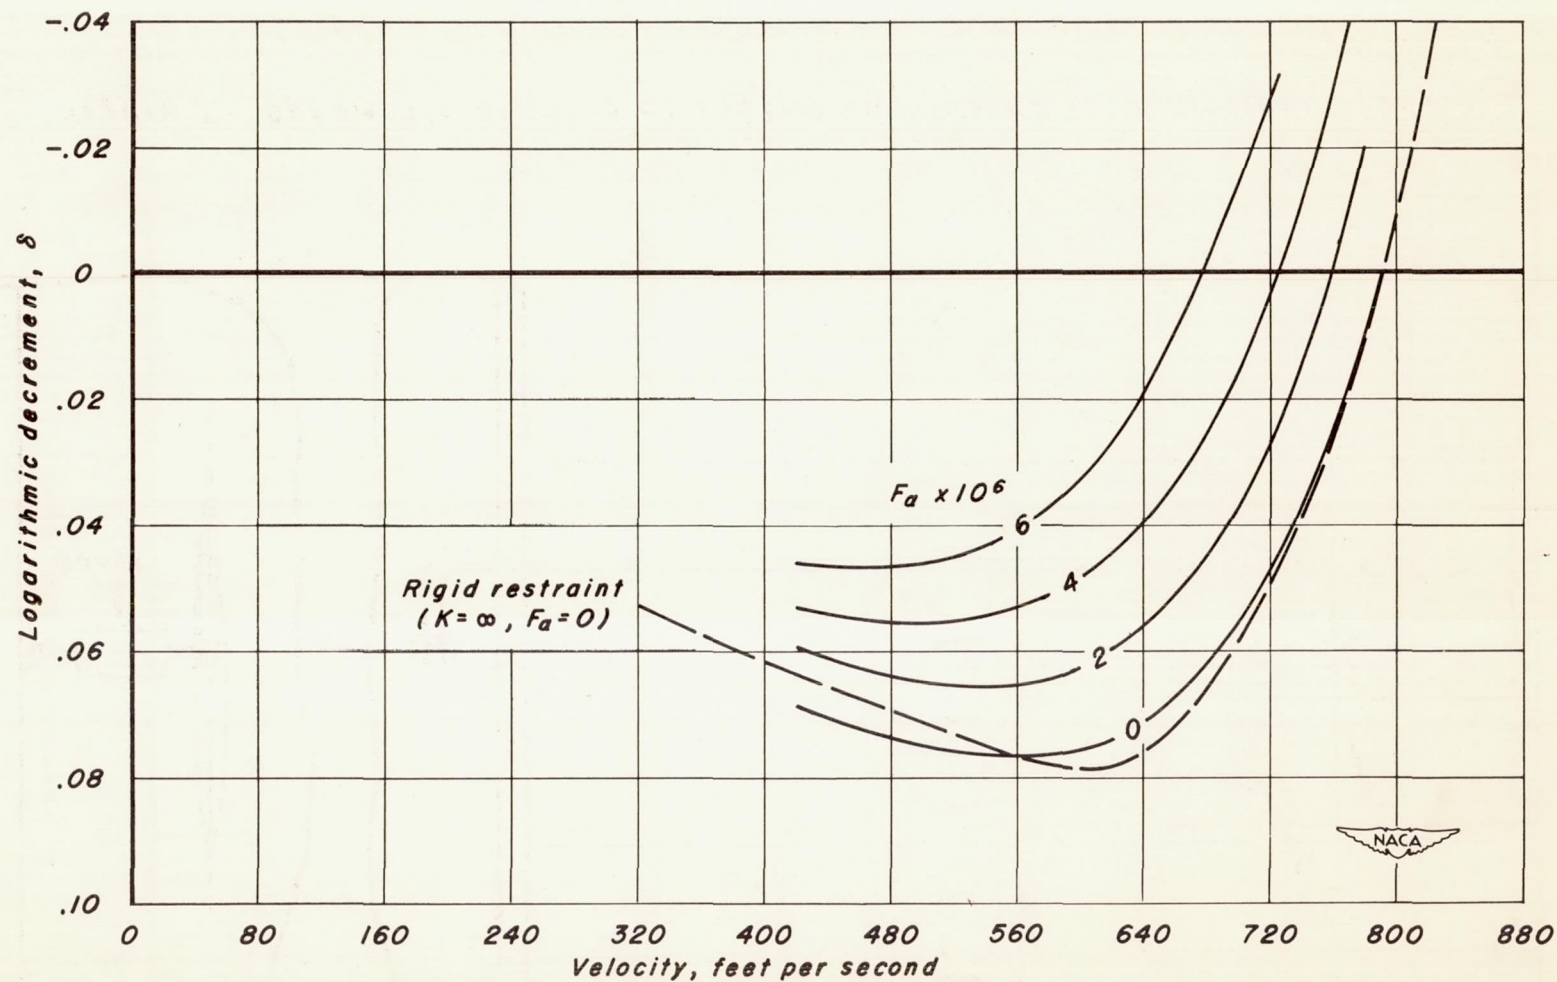
Figure 8.- Variation of the logarithmic decrement with airspeed for various values of feedback amplitude parameter. K , 160,000 foot-pounds per inch.

The system was first considered with locked elevator and no structural feedback ($z=\beta_2=0$) at several velocities from 420 to 820 feet per second and a density of 0.00161 slugs per cubic foot corresponding to that in the wind tunnel at the occurrence of flutter. This was done to establish the effect of speed on the aerodynamic damping of wing-flap combination for the purpose of comparison with the test results, and also to establish a basis to which the subsequent results could be referred. The results are shown in figure 8 by the curve labeled $K = \infty$, $F_\alpha = 0$. On this curve, as well as the remaining figures, points below the axis represent a stable condition, points above an unstable condition, and points on the axis a neutrally stable or flutter condition. The curve labeled $F_\alpha = 0$ represents the condition of restraint being supplied by the boost ($K = 160,000$ foot-pounds per inch) and no feedback. Comparison of these two curves shows that the flutter speed is the same although there are differences in stability at lower speeds.

The remaining curves of figure 8 are for several values of the feedback amplitude parameter and indicate a significant reduction in flutter speed due to structural feedback. The value of F_α derived from the experimental measurements is approximately 10×10^{-6} , considerably greater than any of the values shown in figure 8.

Results similar to those shown in figure 8 were obtained for boost stiffness parameters of 120,000 and 80,000 foot-pounds per inch. The effect of feedback amplitude parameter was similar to that shown in figure 8; therefore these results are not presented in this form, but rather as shown in figure 9. In this figure, the effect of changing the boost stiffness parameter is shown for two representative values of the feedback amplitude parameter. It will be noticed that for zero feedback

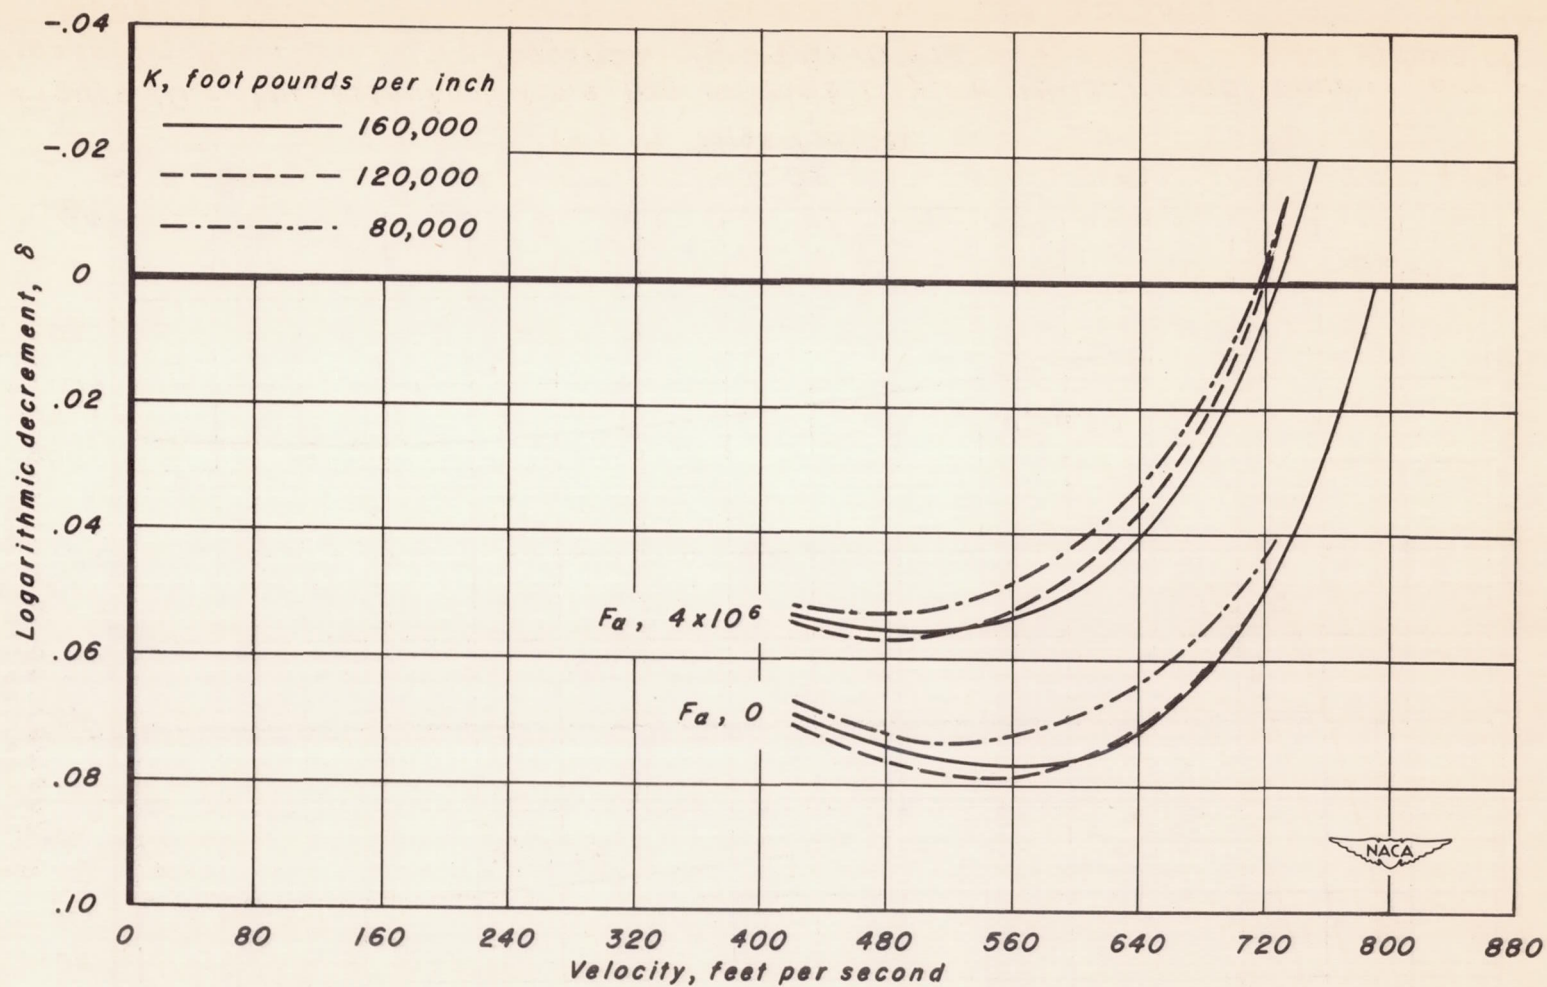
Figure 9.-The effect of variations in the boost stiffness parameter.

Considering now the curves of figure 9 for a feedback amplitude parameter of 4×10^{-6} , it is seen that as the boost stiffness is reduced the flutter speed is reduced. This trend is believed to be due to the presence of a relatively greater amount of the free-surface mode than was the case for zero feedback. For the zero feedback condition, the amplitude of the free-surface mode of the elevator is less than 5 percent of the amplitude of the rigid-restraint mode. On the other hand, for the conditions represented by these curves the amplitude of the free-surface mode is approximately 30 percent of that of the rigid-restraint mode and, in addition, this ratio increases as the boost stiffness decreases. It is reasoned that this amount of the free-surface mode is significantly destabilizing since, in general, a free surface is less stable than a fixed surface. It might seem that as the boost stiffness is reduced the effect of feedback, which has been shown to be destabilizing, would be reduced and thus, other factors remaining unchanged, there would be an increase in stability. However, since the free-surface mode increases as the boost stiffness decreases, it appears that the effect of this mode is predominant. This is not to imply that structural feedback is less important than the boost stiffness insofar as affecting the flutter speed is concerned. Rather the opposite is the case, as can be seen from figures 8 and 9.

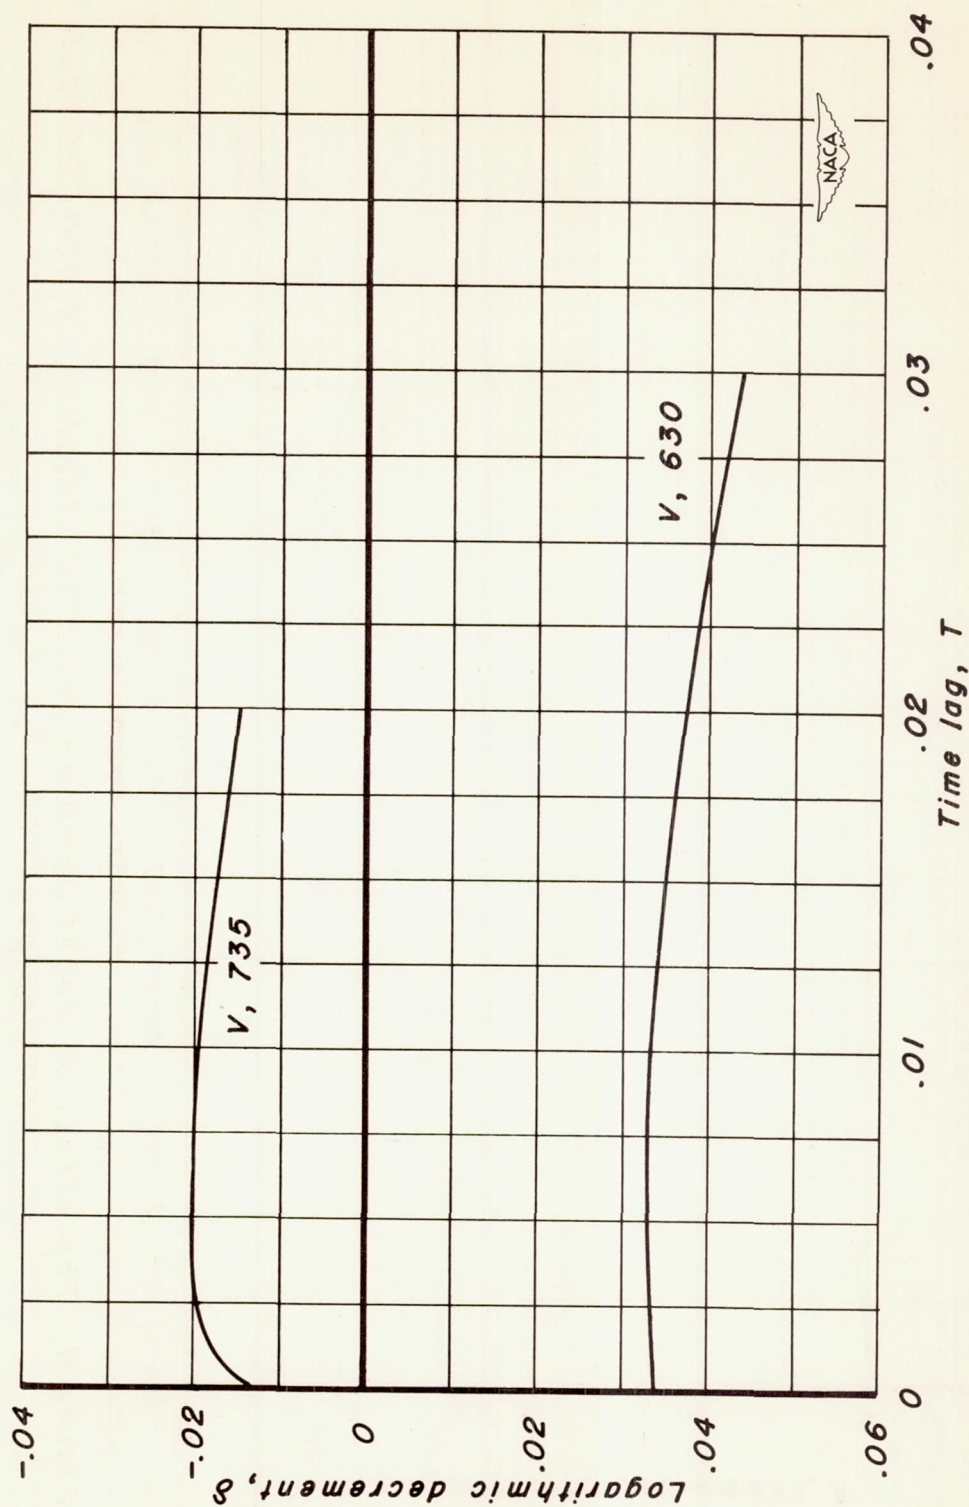
Figure 10.- The effect of time lag on stability. K , 160,000 foot-pounds per inch. F_a , 4.5×10^{-6} .

The effect of time lag of the feedback signal at two velocities is shown in figure 10. The lower velocity considered here is approximately that for maximum stability with zero time lag and the higher velocity is that for an unstable condition. (See fig. 8.) It is seen that the effect of time lag is essentially the same for both of these velocities. A time lag of 0.001 second represents a phase lag of approximately 20° at 50 cps, or it can be interpreted as the time required for sound to travel approximately 20 feet in solid aluminum. It is concluded that time lag has little effect.

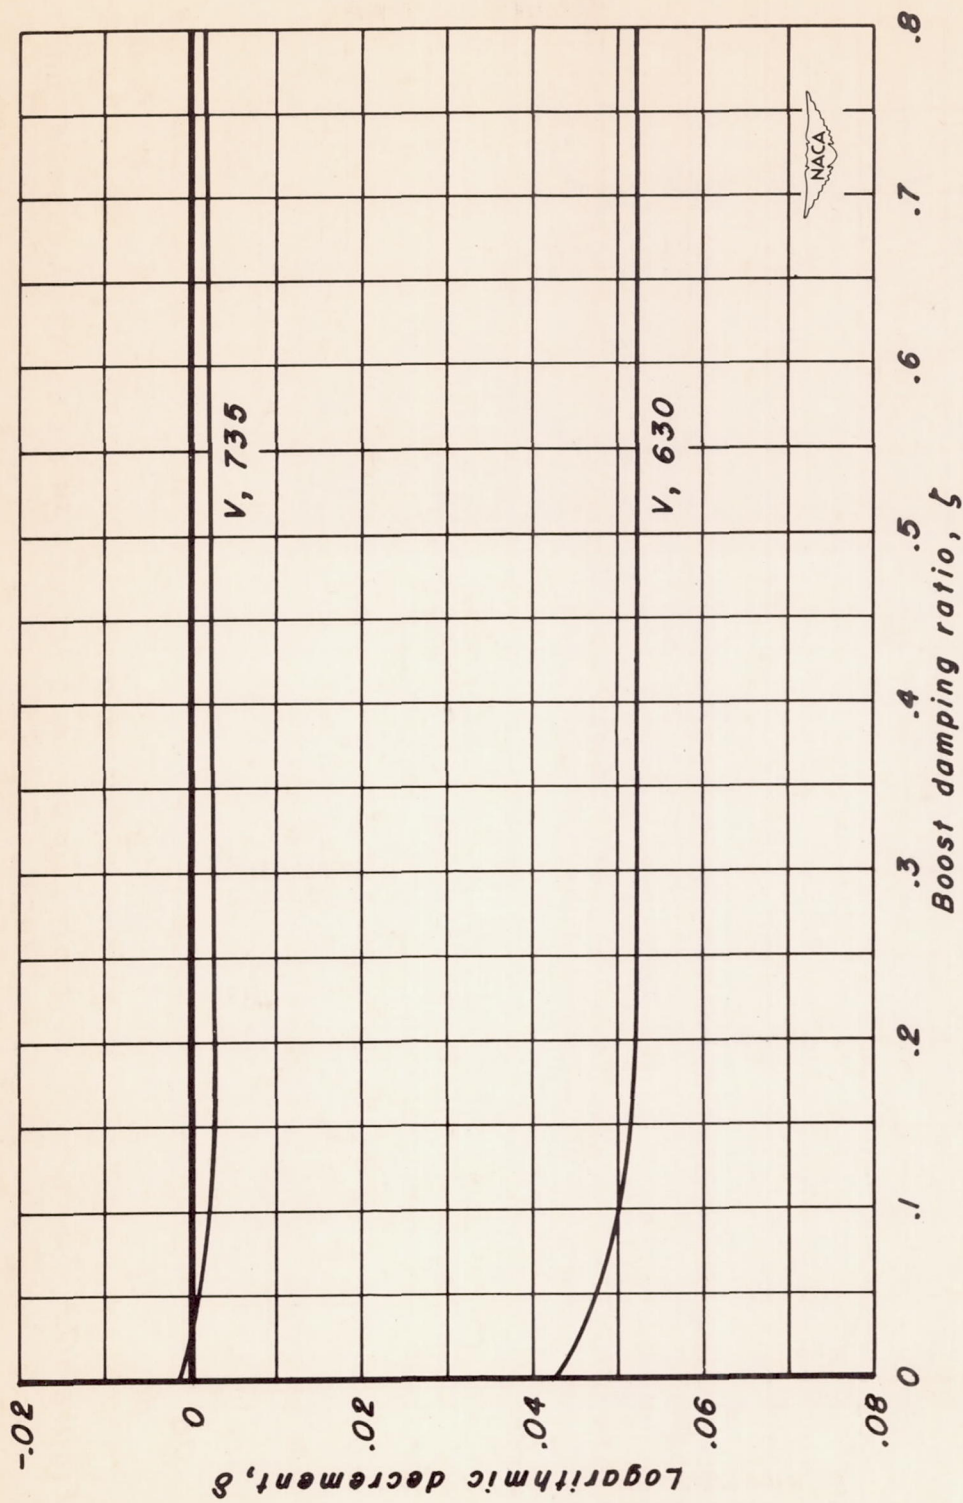
Figure 11.- The effect of boost damping ratio on stability. $K, 160,000$ foot-pounds per inch. $F_a, 3 \times 10^{-6}$.

The effect of the boost-damping ratio is shown in figure 11 for the same velocities and boost stiffness parameter as in figure 10, but for a different value of F_α . The results show that the damping ratio has little effect, especially for values greater than 0.2.
